DEPARTMENT OF TRANSPORTATION

Quality Assurance and Source Inspection

Contract #: 04-0120F4Cty: SF/ALA Rte: 80 PM: 13.2/13.9File #: 1.28**WELDING INSPECTION REPORT****Resident Engineer:** Casey, William**Address:** 333 Burma Road**City:** Oakland, CA 94607**Report No:** WIR-027437**Date Inspected:** 10-Apr-2012**Project Name:** SAS Superstructure**OSM Arrival Time:** 700**Prime Contractor:** American Bridge/Fluor Enterprises, a JV**OSM Departure Time:** 1730**Contractor:** American Bridge/Fluor Enterprises, a JV**Location:** Job Site

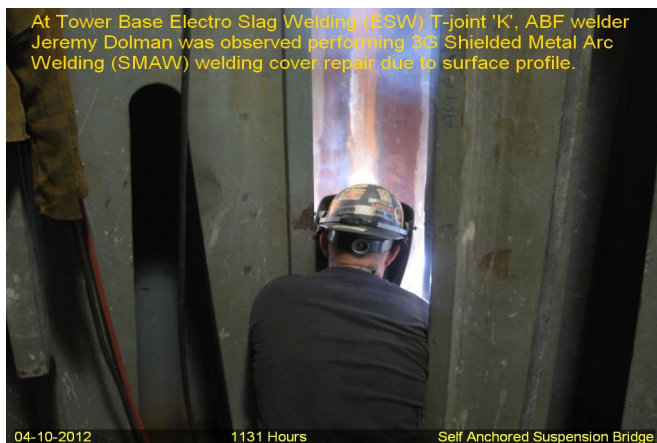
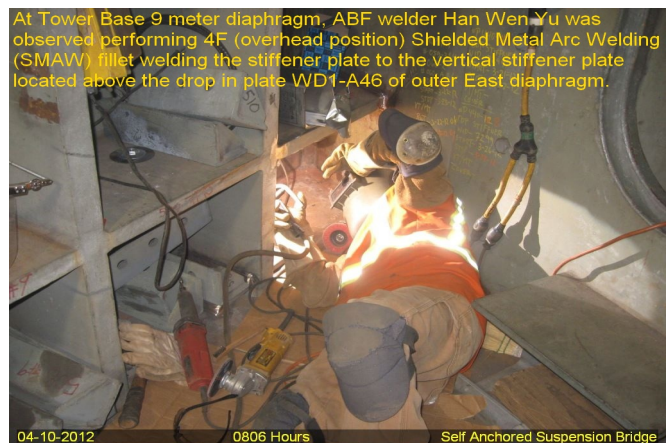
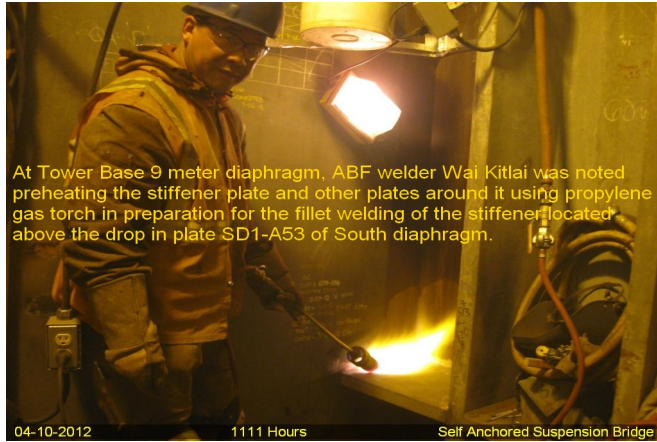
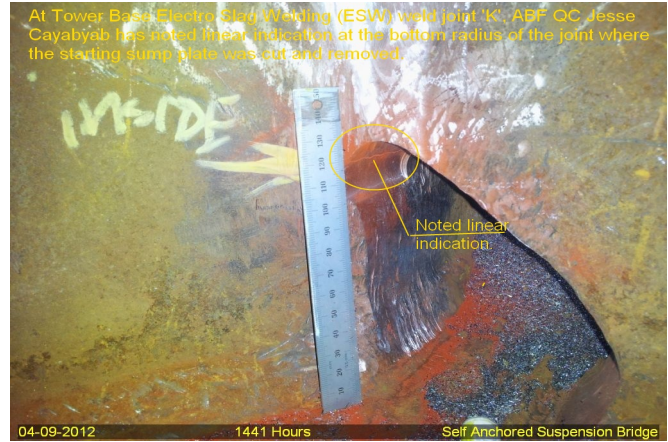
At Tower Base 9 meter South external diaphragm, this QA Inspector randomly observed ABF personnel Jin Pei Wang perform 2F (horizontal position) fillet production welding on the 1" thick fit lug to the 45mm thick diaphragm plate on one side and to the 60mm thick vertical stiffener plate on the other side. The welder was using the dual shielded Flux Cored Arc Welding (FCAW-G) with E71T-1M, 1/16" diameter wire electrode and implementing Caltrans approved Welding Procedure Specification (WPS) ABF-WPS-D15-F3200-2. This QA Inspector observed ABF personnel using Miller Proheat 35 Induction Heating System to preheat the plates being welded prior welding. This QA Inspector observed QC Inspector Bernie Docena using a Fluke infra red temperature gauge to verify the preheat temperature of more than 225°F. This QA Inspector performed a verification of the welding parameters and observed 270 amperes and 24.5 volts. The welding appeared to comply with Welding Procedure Specification (WPS) ABF-WPS-D15-F3200-2. At the end of the shift, the welder was still continuing the fillet weld on two sides of the six (6) fit lugs marked W092-23 to W092-28. The welder performed the post weld heat treatment (PWHT) on the fit lugs using the same preheat temperature and machine and held for three (3) hours as required.

At Tower Base 9 meter inner East external diaphragm, this QA Inspector randomly observed ABF personnel Xiao Jian Wan continuing to perform 4F (overhead position) fillet production welding on the perimeter C10 channel to 45mm thick diaphragm plate fillet weld joint W099-3. The welder was noted welding 6mm fillet between one side

At Tower Base 9 meter inner East external diaphragm, this QA Inspector randomly observed ABF personnel Luo Xiao Hua continuing to perform 4F (overhead position) fillet production welding on the perimeter C10 channel to 45mm thick diaphragm plate fillet weld joint W099-4. The welder was noted welding 6mm fillet between one side of the channel top flange and diaphragm plate per detail 1 of the FW3 drawing. The welder was using the 3.2mm diameter E7018H4R electrode and implementing Caltrans approved Welding Procedure Specification (WPS) ABF-WPS-D15-F1200A. This QA Inspector observed ABF personnel using propylene gas torch to preheat the plates being welded prior welding. This QA Inspector observed QC Inspector Steve Mc Connell using a Fluke infra red temperature gauge to verify the preheat temperature of more than 150°F. This QA Inspector performed a verification of the welding parameters and observed 128 amperes on the 3.2 diameter electrode. The welding appeared to comply with Welding Procedure Specification (WPS) ABF-WPS-F1200A. At the end of the shift, SMAW fillet welding was still continuing and should remain tomorrow.

At Tower Base Electro Slag Welding (ESW) T-joint 'K', ABF welder was observed performing 3G Shielded Metal Arc Welding (SMAW) welding cover repair on welded joint due to unacceptable cover profile. The welder was using SMAW with 3.2mm diameter E7018H4R electrode implementing Caltrans approved Welding Procedure Specification (WPS) ABF-WPS-D15-1000 Repair. The joint was preheated to more than 300°F using propylene gas torch prior welding. ABF QC Jesse Cayabyab was noted on site to monitor the welding parameters with measured working current of 130 amperes during welding. During the shift, ABF QC has informed this QA that during his MT on the bottom of the same ESW weld joint, he noted a linear indication where the starting sump plate was cut and removed. QC also informed this QA that QC will initiate the Weld Repair Report (WRR) and get approval before excavating the linear indication and get welded.
